## ATTACHMENT D

**SAN DIEGO REGIONAL WATER QUALITY CONTROL BOARD MEMORANDUM**

**TO:** BOB MORRIS, SENIOR WRC ENGINEER  
**FROM:** ELIZABETH LAIR WILLIAMS, ENVIRONMENTAL SPECIALIST  
**SUBJECT:** SITE INSPECTION OF POST CONSTRUCTION BMPs SERVICING HIGHWAY 73 IN THE AREA OF LAGUNA BEACH  
**DATE:** 01/25/01  
**CC:** JOHN ROBERTUS, EXECUTIVE OFFICER

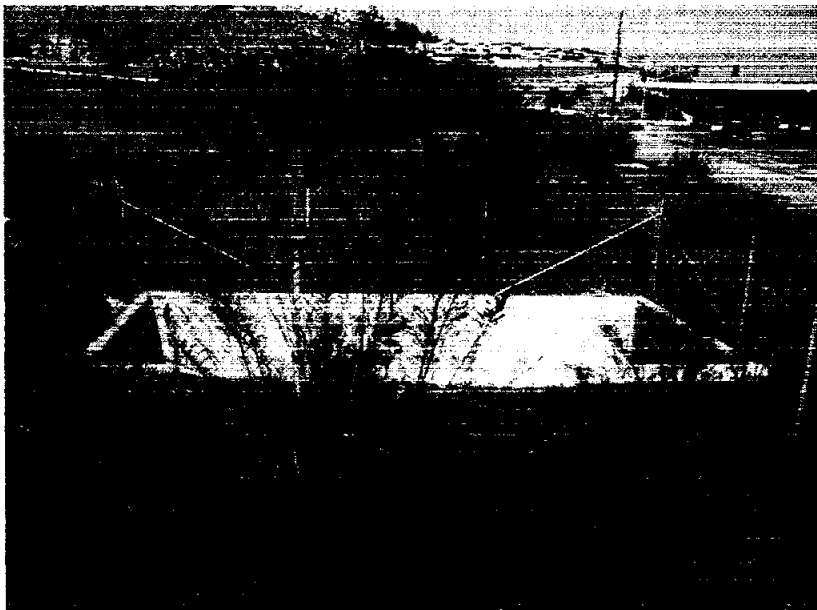
**IMAGE 1**

Storm Water Treatment  
Area for Toll Road 73  
outside of Laguna Beach  
on El Torro Road

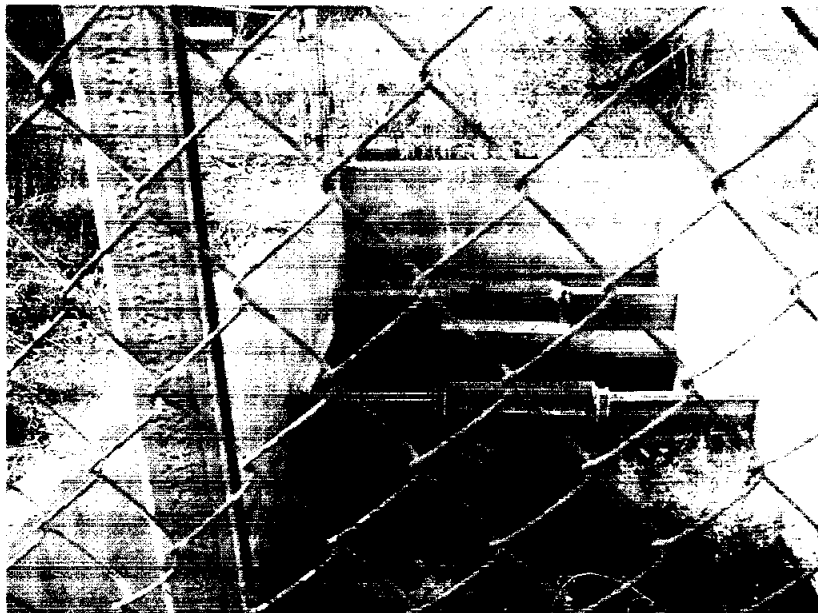
IMAGE 3

Storm Water Treatment Area for Toll Road 73 outside of Laguna Beach on El Torro Road.

- Growth of vegetation illustrates the over loading of the BMP with sediments
- Broken weirs are visible

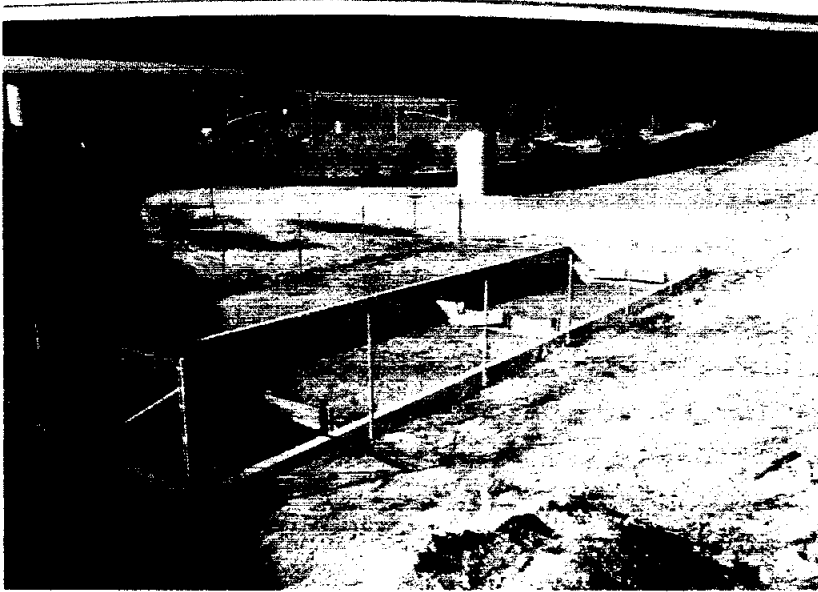
IMAGE 4

Storm Water  
Treatment Area near  
the on ramp from El  
Torro Road to Toll  
Road 73.

- Discoloration is  
suspected to illustrate  
overloading of the  
BMP with  
hydrocarbons and a  
lack of a proper  
maintenance  
program

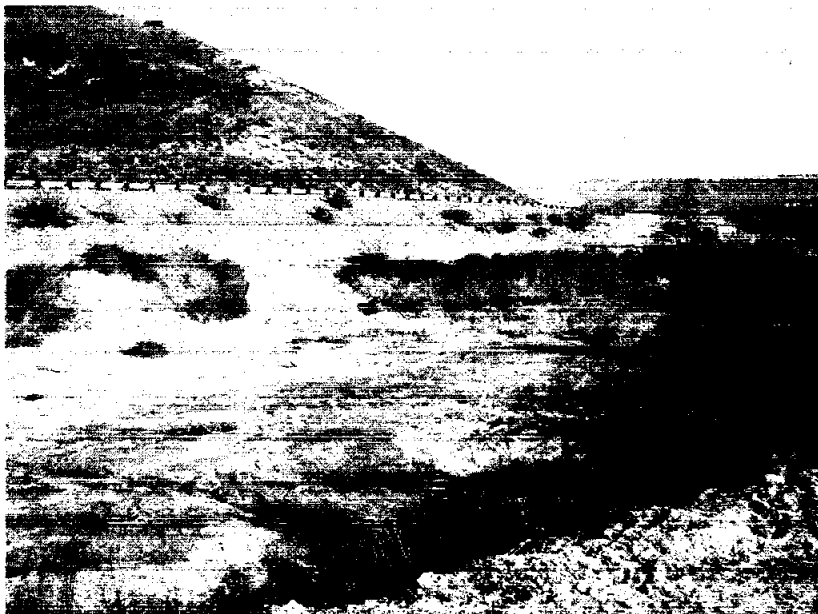
IMAGE 5

Storm Water  
Treatment Area  
near the on ramp  
from El Torro  
Road to Toll Road  
73. This picture  
illustrates the  
sediment treatment  
pond which works  
in conjunction with  
the BMP pictured  
in Image 4.
